Manhole Inspection Summary

Manhole # S65I__013MH

Insp Date: **1/10/08 12:36 PM**

Location Address: **550 Dundalk Ave.**

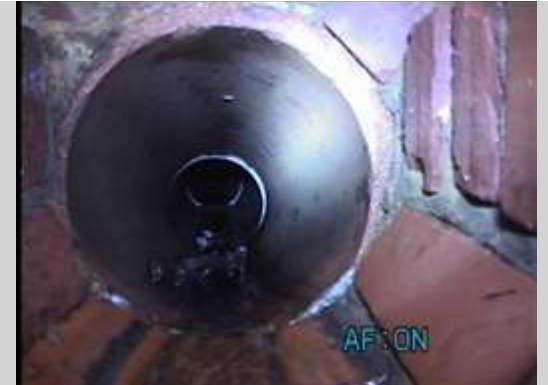
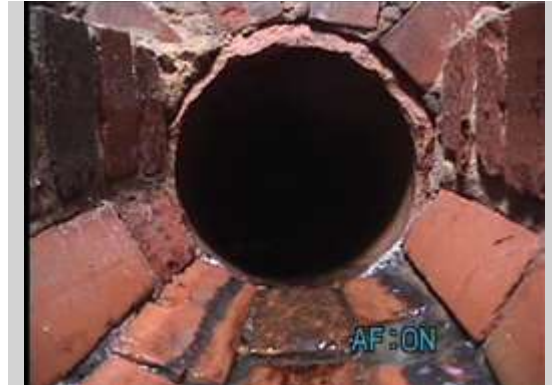
12 O'Clock Outflow

8 in. Circular Gravity Sewer
Pipe Out @ 12 O'Clock

Pipe Height: **8.4** (in.) Rod and Bar (Angled)
Pipe Material: **Clay** ☐ Pipe Lined
Invert Depth: **7.20** (ft.) Flow Characteristics: **Slow**
Deposits: ☒ None ☐ Mud ☐ Sludge ☐ Debris ☐ Grease
Silt Depth: (in.) Deposits Extent:
Infiltration: **None** Pipe Seal Cond: **Sound**

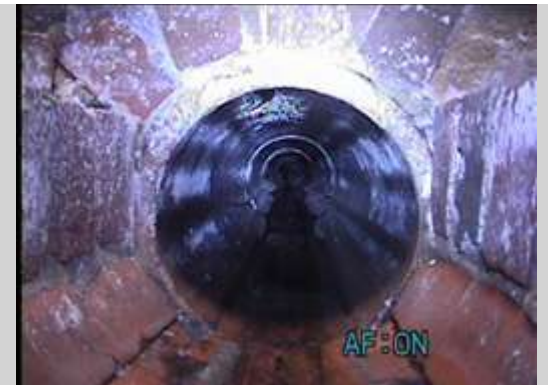
7 O'Clock Inflow

8 in. Circular Gravity Sewer
Pipe In @ 7 O'Clock

Pipe Height: **8.4** (in.) Rod and Bar (Angled)
Pipe Material: **Clay** ☐ Pipe Lined
Invert Depth: **7.10** (ft.) Flow Characteristics: **Slow**
Deposits: ☒ None ☐ Mud ☐ Sludge ☐ Debris ☐ Grease
Silt Depth: (in.) Deposits Extent:
Infiltration: **None** Pipe Seal Cond: **Sound**
